**STATEMENT OF PETER AMES EVELETH
GENERAL COUNSEL, OFFICE OF COMPLIANCE
BEFORE THE SUBCOMMITTEE ON THE LEGISLATIVE BRANCH,
HOUSE APPROPRIATIONS COMMITTEE
July 8, 2008**

Capitol Visitor Center
Office of Compliance
Pre-Inspection

**Eveleth Statement
Attachment 2**

Office of Compliance CVC Pictures

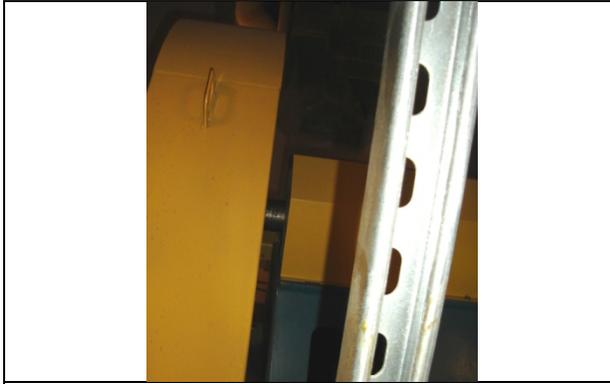
Hazard: Exposed rotating shaft not compliant with 29 CFR § 1910.212(a)(1).

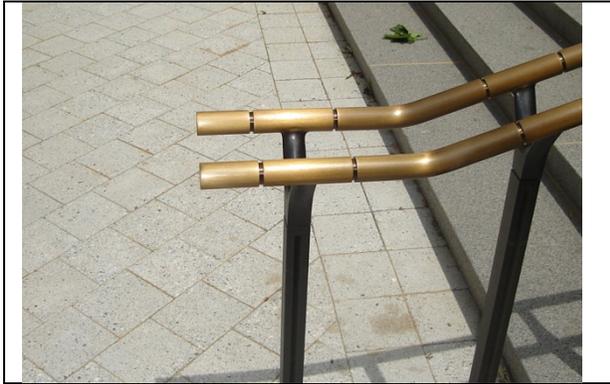
Hazard: Protruding handrails create projection hazard not compliant with 29 CFR § 1910.23(e)(5)(i), 2000 NFPA 101 7.2.2.4.5, ANSI/ASSE A1264.1-2007 Section 5.8 and ASTM E 985-00 Section 4.3.2.

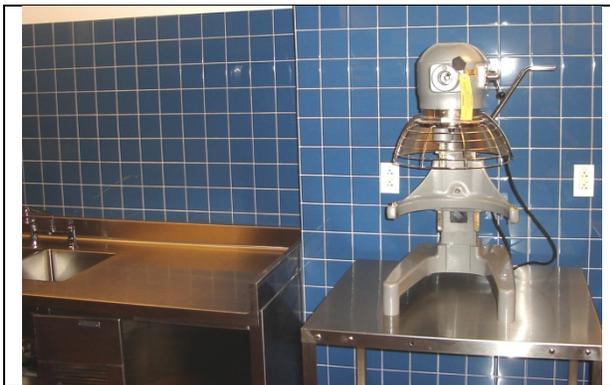
Hazard: Outlets are not protected with Ground Fault Circuit Interrupters, which are required in kitchens due to wet floors by 1999 NFPA 70E Section 110-10.

Solution: Install low cost GFCI outlets in the kitchen and near all water sources.

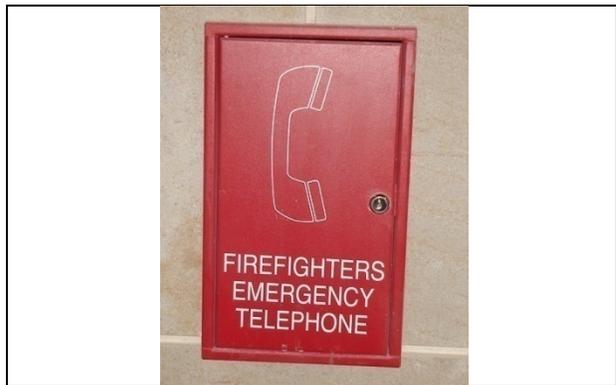
Hazard: Telephones at staging areas are locked, prohibiting use.

Solution: Change lock on cover into a knob or handle that is compliant with 28 CFR Part 36 Appendix A Section 4.27.4.

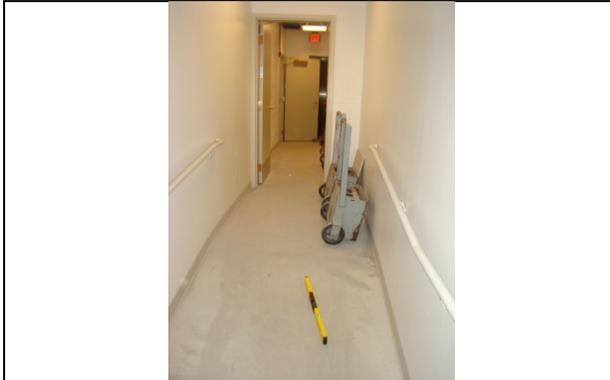
Violation: Ramp is too steep for individuals in wheelchairs and does not comply with 28 CFR Part 36 Appendix A Section 4.8.2.
Solution: Regrade ramp equal to or less than 8.3% grade.

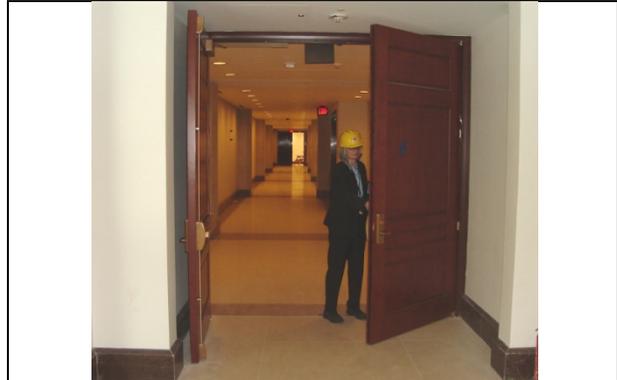
Hazard: Door swings against direction of egress travel, which does not comply with 2000 NFPA 101 7.2.1.4.2.
Solution: Rehang door to swing in the direction of egress travel.

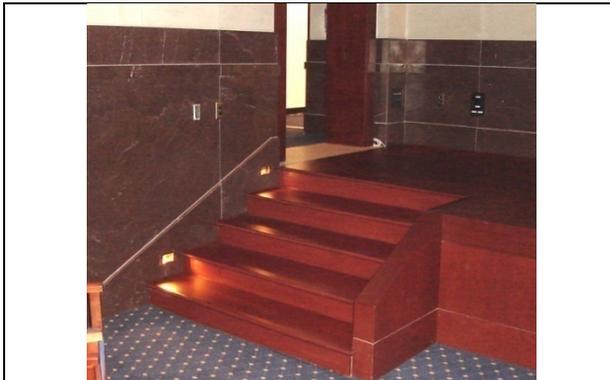
Hazard: Stairway with greater than 4 risers has no handrails, not complying with 29 CFR § 1910.23(d)(1).
Solution: Install handrails compliant with 29 CFR § 1910.23(d)(1).

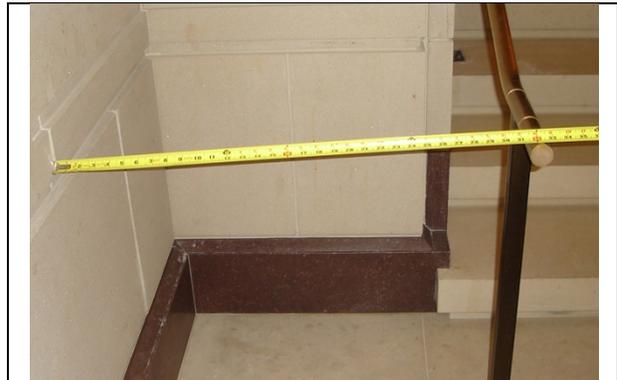
Hazard: Handrail protruding into open space in room.
Solution: End handrail at bottom riser and make compliant with 29 CFR § 1910.23(e)(5)(i), 2000 NFPA 101 7.2.2.4.5, ANSI/ASSE A1264.1-2007 Section 5.8 and ASTM E 985-00 Section 4.3.2..
