## Office of Compliance

### **Report on Americans with Disabilities Act Inspections Relating to Public Services and Accommodations**

July 2007

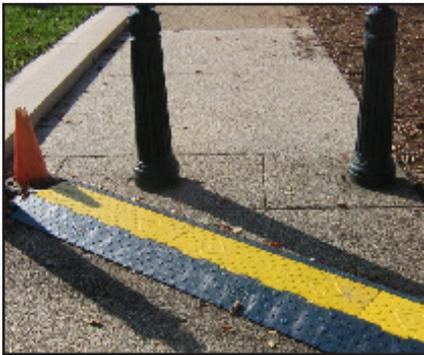
*Figure 1: Non-compliant temporary sidewalk ramp*

complex. A constituent using a motorized wheelchair was injured while crossing a temporary sidewalk ramp that was too steep. The AOC replaced the ramp with an ADA-compliant ramp, and is now working toward a permanent solution. This charge is pending closure.

In 2006 an ADA public access charge was filed with the OOC following an injury to a constituent caused by the steep slope of a temporary ramp on the sidewalk along Independence Avenue. The constituent was visiting Capitol Hill and injured his head when his motorized wheelchair fell over backwards as he was attempting to cross the temporary ramp. The AOC fixed the problem after the OOC raised the issue. The AOC should be mindful about using non-compliant temporary ramps for any project in an area open to the public.

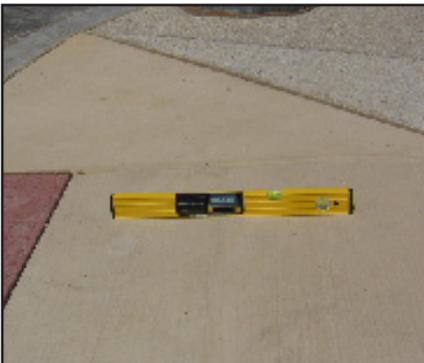
*Figure 2: Non-compliant newly installed sidewalk curb cut*

OOC inspectors have measured numerous sidewalk curb cuts throughout the Capitol Hill grounds that are too steep to be considered accessible.<sup>3</sup> Some of the non-compliant curb cuts were recently installed.<sup>4</sup> The OOC recommends that the AOC survey all of the Capitol complex’s sidewalks and grounds to ascertain which curb cuts are not in compliance with the ADA, and immediately fix those that are non-compliant. Accessible sidewalks are a fundamental public access issue for any constituent who is in a wheelchair.<sup>5</sup>

<sup>3</sup> Curb ramps must have 8.3% rise or less and must otherwise comply with 28 C.F.R. Pt. 36, App A §4.7.

<sup>4</sup> New curb cuts on existing sidewalk are alterations, and therefore must strictly meet the requirements of the ADA regulations. 28 C.F.R. §36.402(b)(2).

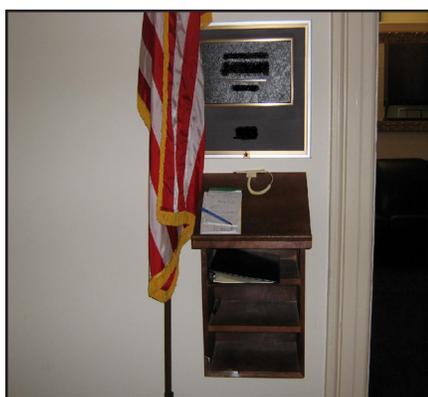
*Figure 3: Braille signage not approachable within three inches*

Objects placed in front of brailled and raised character signage present a barrier to an individual who must touch the sign to understand it. The OOC recommends that building Superintendents and the Chief Administrative Officer (CAO) regularly remind each office to remove items in front of hallway signage.

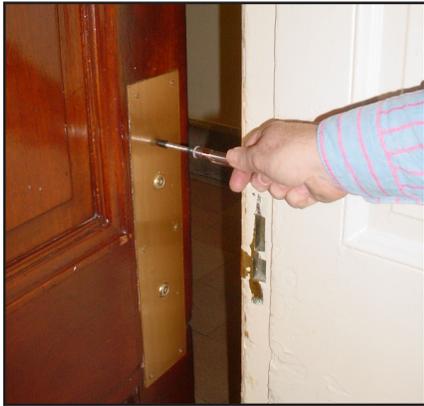
Figure 4: Testing restroom door weight

The force required to open the door to the designated accessible restrooms in many buildings is too great.<sup>6</sup> If the door weight is too heavy, an otherwise accessible restroom becomes inaccessible to an individual with mobility impairments. The OOC recommends that the AOC periodically measure and adjust the door opening force of all public restrooms in all buildings that are designated as accessible. Alternatively, the AOC should install automatic door openers for the doors on all designated restrooms.

<sup>6</sup> To be compliant, the maximum force needed to open these doors must be 5 lbf. 28 C.F.R. Pt. 36, App A §4.13.11(2)(a).
