fast facts

Exposed, Energized Wiring and Electrical Components

February 2010

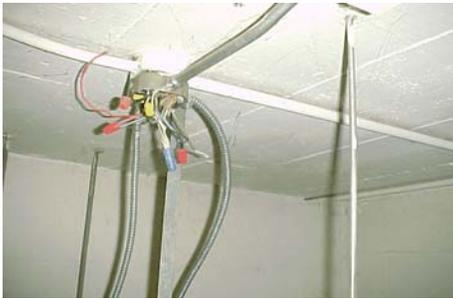
Figure 1: Potentially hazardous electrical junction box without cover

Junction boxes without covers are the most common places to find exposed and hazardous wires. Electricians use junction boxes to connect new installations or extend existing installations. When energized junction boxes are uncovered, the wiring is vulnerable to damage and accidental contact. If easily combustible materials, such as paper or cardboard,

are stored near unprotected energized wiring, a spark or electrical arc could easily start a fire. Figures 1 and 2 are examples of junction boxes with exposed wiring.

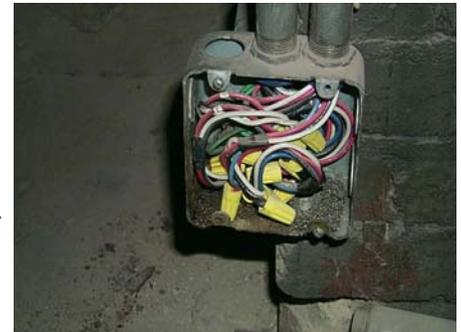
Figure 2: Potentially hazardous wall switch or outlet box without cover

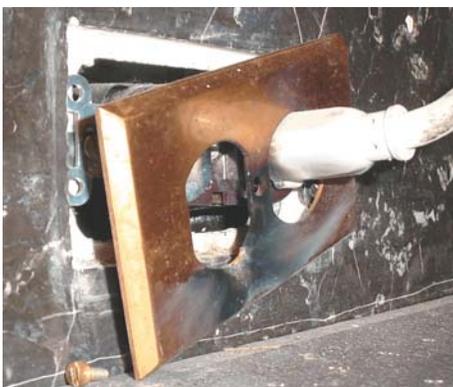
Figure 3: Potentially hazardous burnt outlet with displaced cover

Electrical outlets and light switches with broken, displaced, or missing covers may also expose wiring which endangers any employee plugging in an appliance or turning on a light. Both OSHA and NFPA require that outlets and switches remain covered. Figure 3 shows an outlet with a displaced cover and a burn mark, and Figure 4 shows a completely uncovered outlet next to a light switch. This is an especially dangerous hazard for anyone trying to find the switch in the dark.

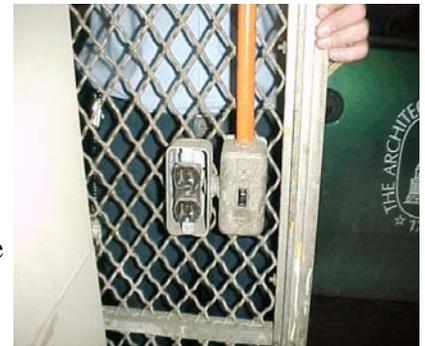
Figure 4: Potentially hazardous outlet with no cover next to switch

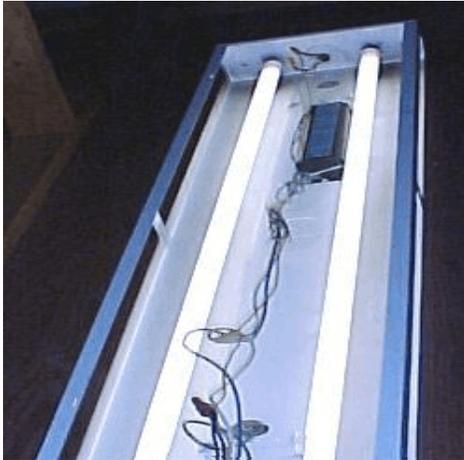
Figure 5: Missing cover on fluorescent light fixture exposes wiring

Electrical hazards may also be found in light fixtures. Uncovered fluorescent lights, incandescent light fixtures without bulbs, or light fixtures hanging by wiring are all dangerous. Fluorescent lights have energized wiring, starters, and ballasts under their protective covers. If the light's cover is not properly replaced, these hazards are exposed. When an incandescent bulb is removed and not replaced, the open socket presents a hazard if it remains energized; and therefore, it is best to leave the burnt bulb in the socket to cover the electrical contact until the bulb is replaced. The fluorescent light fixture without a cover in Figure 5 shows exposed wiring. Figure 6 shows an improperly mounted light fixture with an open socket and exposed wiring.

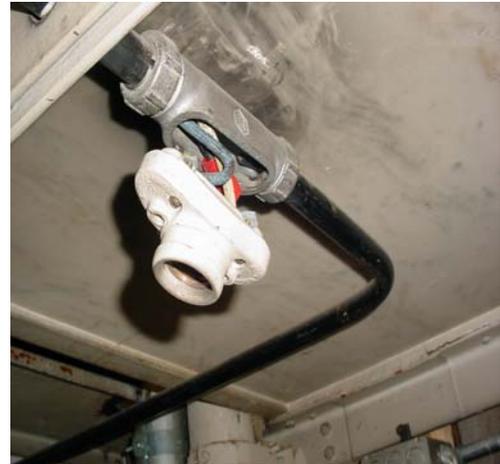
Figure 6: Light fixture not properly secured to mounting with open socket and exposed wiring

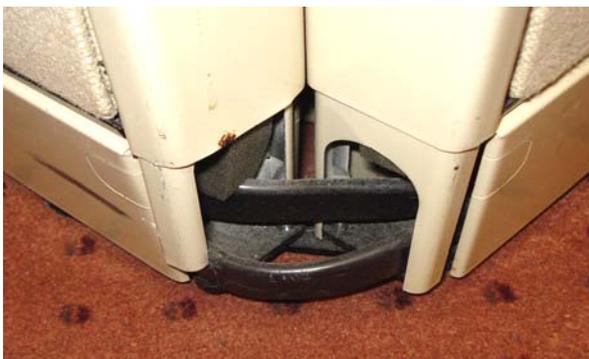
Figure 7: Exposed power wiring at corner unprotected from impact and damage

Modular furniture provides electrical power and must protect occupants from shock hazards. Because the furniture has live electrical wiring running through it, it is important to enclose and protect the wiring within each module. Corner and baseboard wiring covers are needed to prevent accidental shock hazard contact and damage to wiring. Figures 7 and 8 are examples of unprotected wiring in modular furniture that people could contact accidentally.

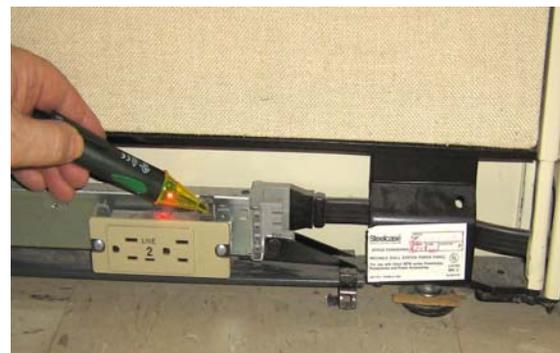
Figure 8: Exposed baseboard electrical supply outlet and service without its cover
